electrical focus

Death of Electrical Worker Highlights the Need to Shroud Live Parts

On 26 April 2001, an electrician was tragically electrocuted whilst working in a switchboard at a Perth quarry.

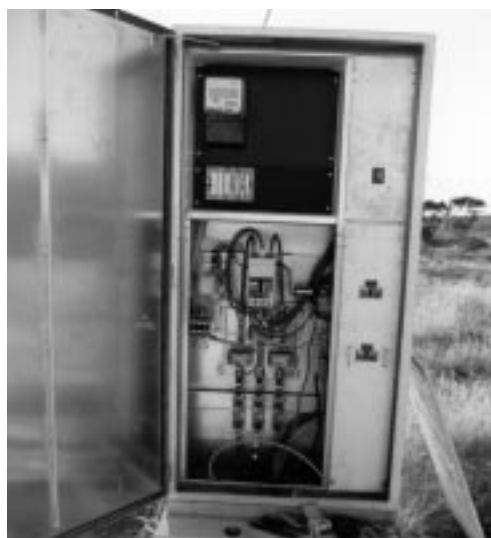
The electrician was in the process of installing a new sub mains circuit breaker at a 415 volt main switchboard. He isolated the electrical equipment in the main switchboard by removing the three incoming phase-links at the bottom of the switchboard cubicle. There was no insulation placed over the line side ("live") terminals of the phase-links.

It appears that, as the electrician was working in the switchboard, he leant forward and his forehead inadvertently made contact with two of the "live" phase-links' terminals.

An electrician was tragically electrocuted whilst working in this switchboard

Working on or in close proximity to live electrical equipment should always be avoided. Every effort should be made to isolate all circuits and equipment from the electricity supply.

However, where the equipment cannot be isolated and it is necessary to work in the vicinity of live parts, the following safety measures must be taken to reduce the possibility of an accident happening:

- An assessment must be made of the associated risks prior to commencing any work on or in close proximity to any live electrical equipment. Action must then be taken to eliminate the risks.
- Appropriate and suitable protective clothing and accessories suitable for the task must be worn.
- Insulated barriers/mats/covers must be positioned over all live equipment/parts to effectively prevent contact with live parts. This insulation will also prevent flashovers from taking place in the event that conducting tools or parts fall onto live equipment.
- Tools and equipment must be appropriate for the work to be carried out.
