energy

Bulletin

Coroner's findings on electrocution

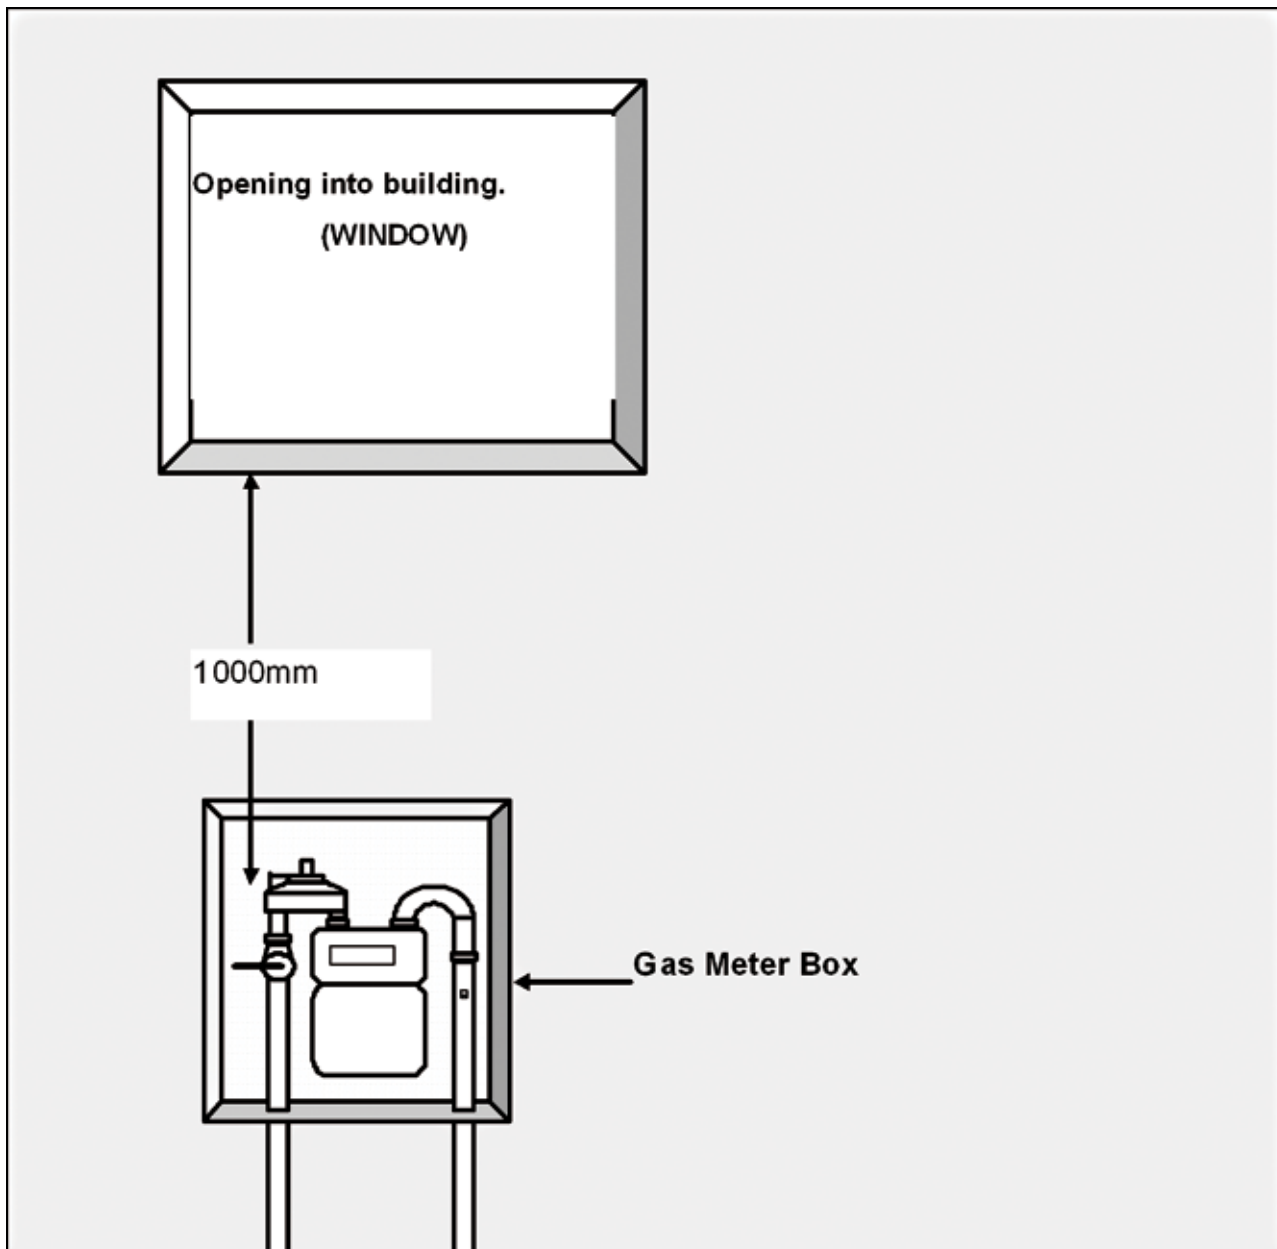
The Gas Distribution Networks AS/NZS 4645: 2008, Part 1: Network Management, Appendix K figure (1) requires an opening into a building to be greater than 1000mm above the gas service regulators relief vent contained in the gas meter box (see diagram below).

Gas service regulators are now required to have an internal relief. In the unlikely event that the relief valve discharges gas into the atmosphere, there is a possibility of gas entering a building if an opening is less than that as detailed in this code.

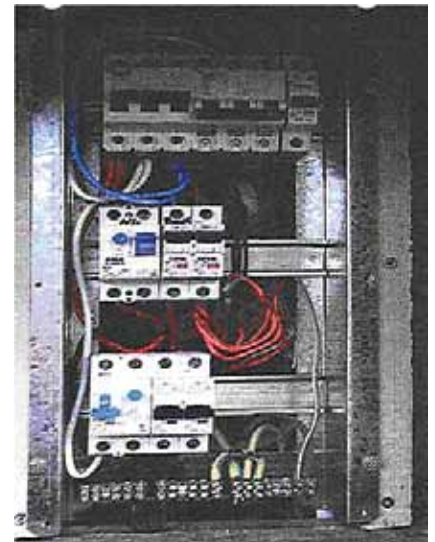
A recent domestic inspection revealed a main switchboard with a new metallic DIN kit and circuit breakers, where the electrician had failed to earth the main switchboard DIN kit (metallic parts) (see picture). This installation did not comply with AS/NZS 3000:2007, Wiring Rules, Clauses 5.3.1 and 5.4.1.1 and is also a breach of the Electricity (Licensing) Regulations 1991, Regulation 49(1).

The electrician had mistakenly assumed the main switchboard DIN kit was internally earthed and that it was not required to be earthed separately.

On completion of this inspection, the Inspector issued an Order requiring the switchboard to be earthed and fitted with a temporary earth conductor.

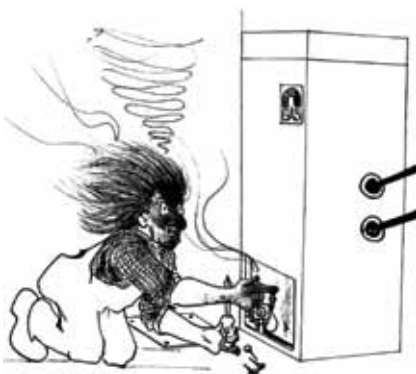
Unfortunately these changes have also had an effect on the number of injuries being sustained when lighting these units for the first time. Earlier models had an opening on the bottom to allow access and removal of both the pilot burner and/or the main burner for servicing. We can equate the size of this opening to the size of a rabbit hole. To improve efficiency the pilot flame sizes have been reduced, the rabbit hole replaced with a mouse hole. The effect of these two changes alone has increased the frequency of delayed ignition and flash-overs much to the danger of the person lighting the water heater.

These flash-overs generally occur when the water heater is lit for the first time or when using LP Gas and the cylinder has emptied causing the pilot light to extinguish. Even though the lighting instructions call for a period of 5 minutes after purging, the incident reports received by EnergySafety identify mostly burns received on the face and arms.

An incident reported recently occurred after the gas fitter had purged the gas line and ignited the pilot, however it failed to remain alight. The gas fitter then checked the pilot and struck the piezo igniter. With that a fireball rushed out from under the water heater rolling over his head causing superficial burns to his face and arms needing a visit to hospital.

The lesson here is to ensure all the air is purged from the gas line, secondly if you wish to view the pilot use a small mirror to confirm the ignition and subsequent lighting of the main burner. One manufacturer at one stage was aware of the difficulty in sighting the pilot and main burner and installed a polished aluminium reflector.

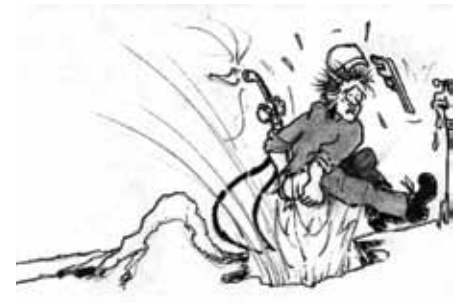
In the most recent incident a plumber was working on the water service in close proximity of the PVC gas service. The plumber was using his oxy set undertaking repairs to the copper water service. Whilst playing the flame on the copper pipe the tip of the flame came in contact with the nearby PVC gas service, weakening the pipe where the internal gas

pressures caused the pipe to weep, the escaping gas was ignited by the oxy torch. The resulting fire was extinguished by the plumber using a fire extinguisher.

Fortunately the gas pressure in the mains that day was between 7 – 10kPa, a low pressure gas area. This may not always be the case as high pressure gas mains can be operated at 200kPa. In these situations the gas service pipe is connected using polyethylene (PE). Rather than the gas pressure causing the gas to weep through the weakened PVC pipe, in the case of high pressure you can expect the internal gas pressure to burst the weakened pipe resulting in a fireball and an intense fire.
