energy

Bulletin

Teenage trade assistant fatality raises timely reminders

ELECTRICAL SAFETY RECALL – Single module RCBO

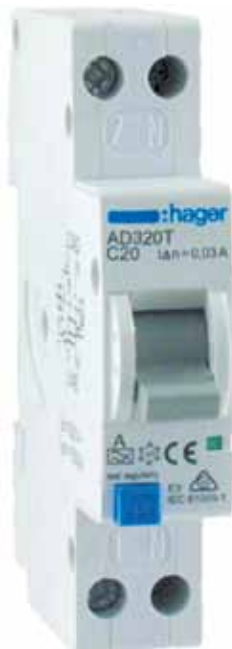
(combination RCD & MCB) Hager
'mono' range AD310T, AD316T,
AD320T & AD325T

**AD310T,
AD316T,
AD320T, and
AD325T**

Some units have been found to malfunction and not switch off the electrical circuit in the event of a fault.

Electrical contractors must stop installing the above products and contact Hager B&R Pty Ltd to arrange return of their stock and/or replacement of the installed products.

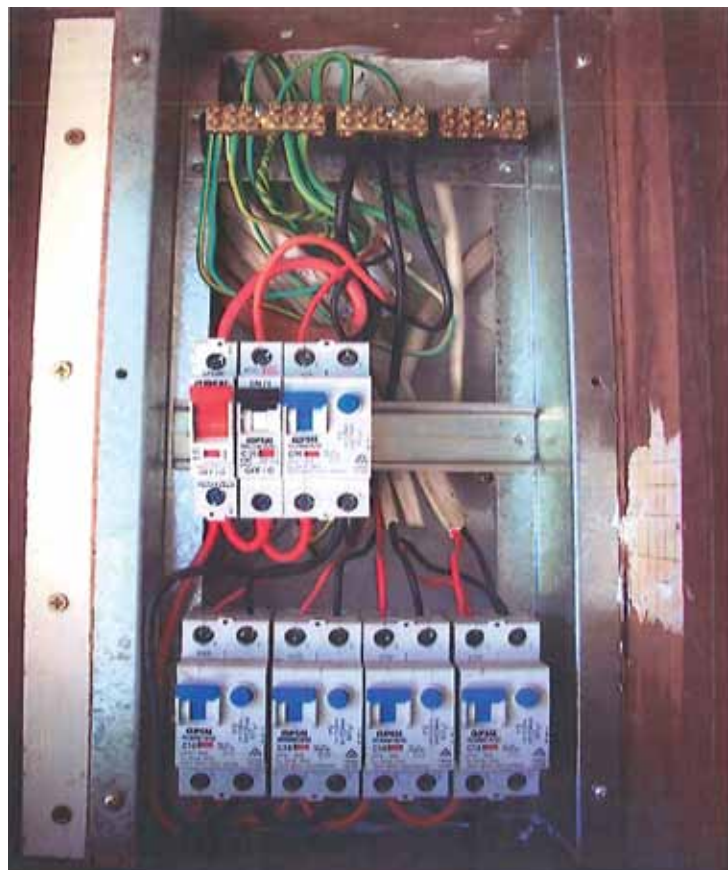
An electrician has been convicted and fined \$8,000 with court costs of \$653.80 for failing to earth the

switchboard DIN rail kit (metallic parts) at a property in Bunbury.

The main switchboard with the DIN rail kit frame not earthed.

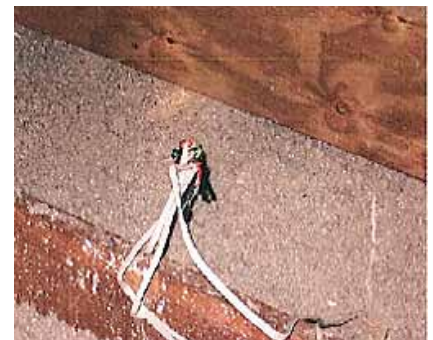
In the 1970s and early 1980s, joints for electrical cables in ceiling spaces of dwellings and buildings were often only wrapped in insulating tape. The insulation tape deteriorates and falls away, exposing live wires.

Unenclosed joint and unterminated cables in the ceiling space.

At that point, your employee should issue an advisory leaflet from EnergySafety to the owner or occupier. This leaflet was produced in August 2011 and will inform them of the situation, associated hazards and rectification requirements. The advisory leaflet (information sheet) can be downloaded from the EnergySafety website at www.energysafety.wa.gov.au

As per the regulation requirements, you are then to notify the network operator of the situation, as unenclosed joints are considered serious defects.

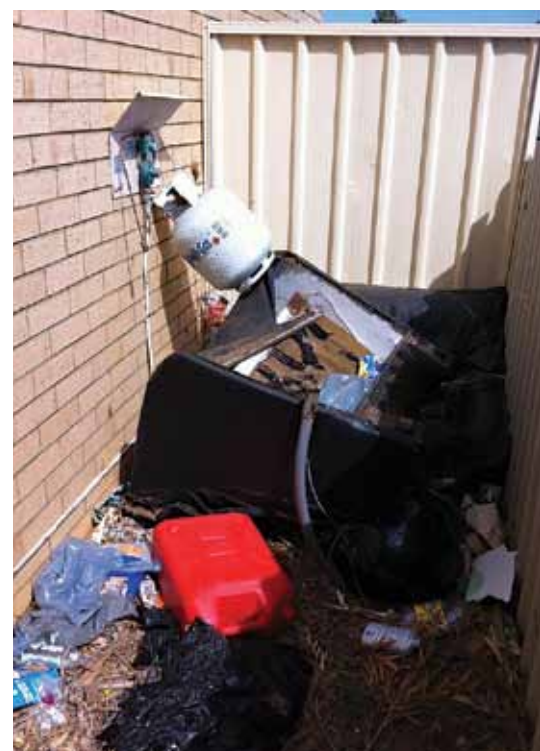
Installations such as the one illustrated are considered temporary and hazardous, with the cylinder in this case balancing precariously on an old couch. The cylinder is not fixed to the wall nor is it on a non-combustible base therefore creating a fire hazard. Furthermore a cylinder in this position could result in serious injury to a small child should it become dislodged from its temporary stand.

It is highly recommended that the standard installation fix for 45kg LP Gas cylinders only be installed. It may be that the consumer just moving into a new residence has only a small load (perhaps a cooktop). Rather than catering for a smaller gas cylinder it is wise to install only a conventional LP Gas installation (changeover regulator and hood) at the recommended height. Should the consumer install more gas appliances in the future there is no need to upgrade that portion of the gas installation.

As a gas fitter always meet compliance and safety requirements and don't change the gas installation to suit the smaller 9kg LP Gas cylinders.
