energy

Bulletin

The Gas Appliance Rectification Programme

electrical

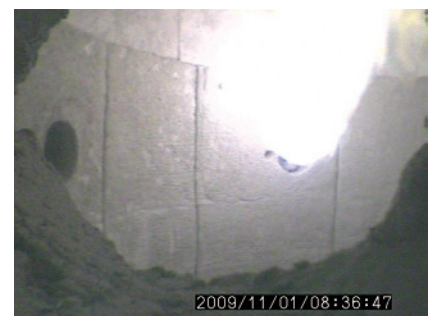
The main burner system, consisting of a pilot and main burner, is intended to be dual fired (capable of using natural gas or heavy fuel oil) however, it is currently only approved for natural gas. The main burner has six nozzles, with the nozzles set equally apart around the circumference of the inlet to the Calciner furnace. The natural gas-fired burner has a 560 GJ/h gas rate.

Calciner 6 burner nozzle

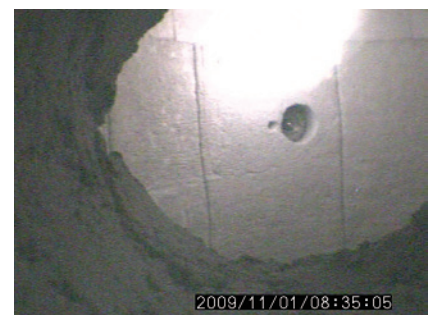
Calciner 6 pilot
